Architectural Services for Design of the  
Commercial Enhancement of Pier Street Car Park.

# ASBESTOS REGISTER

## Pier Street Car Park and Retail

87-89 Pier Street, Perth 6000

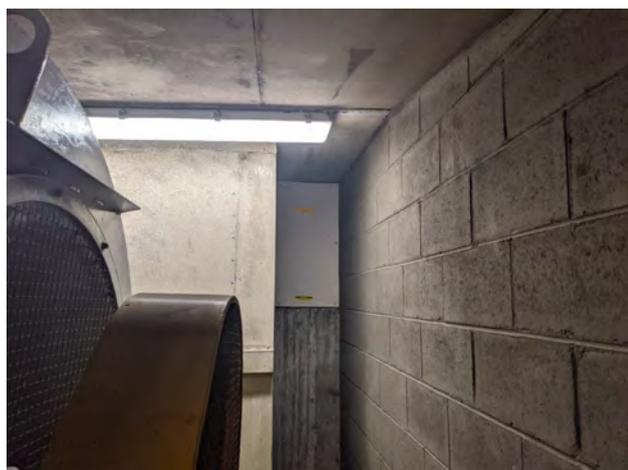
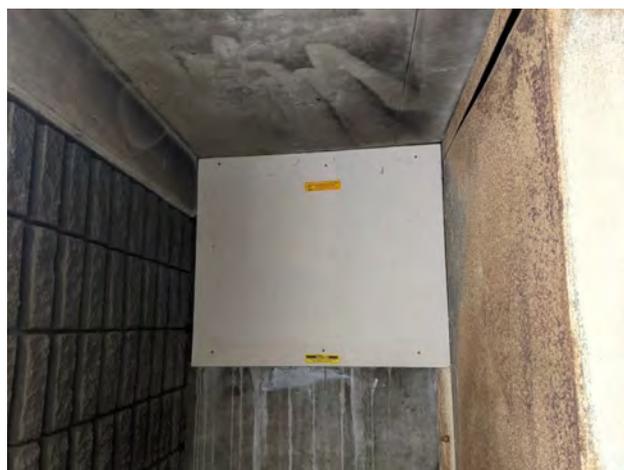
<b>Item Number:</b>	47714	<b>Action Rating:</b>	A4
<b>Location Description:</b>	EF2 & AHU 2	<b>Risk Rating:</b>	Very Low
<b>Item:</b>	Fibre cement wall sheet	<b>Friability</b>	Non-Friable
<b>Material Description:</b>	Cement Product	<b>Disturbance Potential:</b>	Rare
<b>Extent (approx.):</b>	1 m <sup>2</sup>	<b>Condition:</b>	Good (Undamaged)
<b>Building:</b>	Car park	<b>Proposed Actions:</b>	Removal by licensed asbestos contractor during refurbishment or demolition
<b>Level:</b>	Ground Floor, Internal	<b>Additional Comments:</b>	Unsealed, recommend sealing and reapplying warning labels.
<b>Location Number:</b>	001		
<b>Sample Status:</b>	Asbestos Detected	<b>If Removing, Consult:</b>	WorkSafe WA Code of Practice How to Safely Remove Asbestos 2022, Appendix 5, Asbestos cement products;  WorkSafe WA Code of Practice How to Safely Remove Asbestos 2022, Appendix 3, Respiratory protective equipment, AS/NZS 1715:2009 Selection, use and maintenance of respiratory protective equipment and AS/NZS 1716:2012 Respiratory protective devices.

<b>Sample Number:</b>	Previously sampled by QED as 10066		
<b>Label Status</b>	Labelled	<b>If Mitigating Potential Risks, Consult:</b>	WorkSafe WA Code of Practice How to manage and control asbestos in the workplace 2022, Safe work practice 2 - Sealing, painting, coating and cleaning of asbestos cement products;  WorkSafe WA Code of Practice How to Safely Remove Asbestos 2022, Appendix 3, Respiratory protective equipment, AS/NZS 1715:2009 Selection, use and maintenance of respiratory protective equipment and AS/NZS 1716:2012 Respiratory protective devices.
<b>Laboratory Reference:</b>	AEC report No. 93121

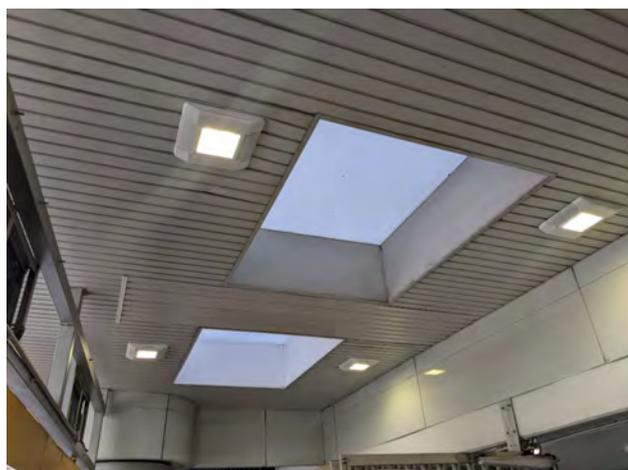
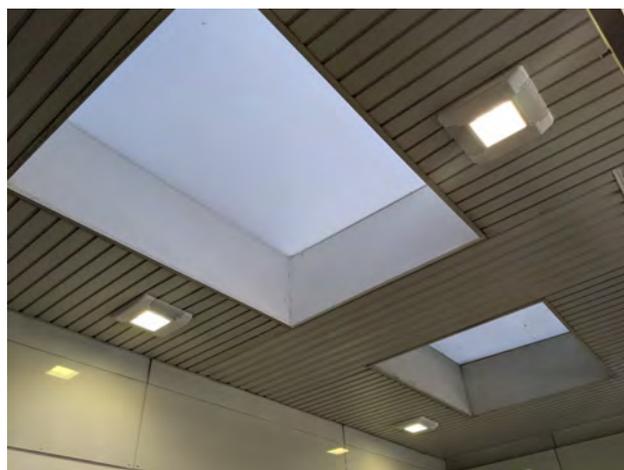
<b>Item Number:</b>	47715	<b>Action Rating:</b>	A4
<b>Location Description:</b>	Skylight, Pier St Entry.	<b>Risk Rating:</b>	Very Low
<b>Item:</b>	Skylight plenum panels	<b>Friability</b>	Non-Friable
<b>Material Description:</b>	Cement Product	<b>Disturbance Potential:</b>	Rare
<b>Extent (approx.):</b>	30 m <sup>2</sup>	<b>Condition:</b>	Good (Undamaged)
<b>Building:</b>	Car park	<b>Proposed Actions:</b>	Investigate prior to refurbishment or demolition
<b>Level:</b>	External Ground	<b>Additional Comments:</b>	At height, unable to sample.
<b>Location Number:</b>	001		
<b>Sample Status:</b>	Assumed Asbestos	<b>If Removing, Consult:</b>	WorkSafe WA Code of Practice How to Safely Remove Asbestos 2022, Appendix 5, Asbestos cement products;  WorkSafe WA Code of Practice How to Safely Remove Asbestos 2022, Appendix 3, Respiratory protective equipment, AS/NZS 1715:2009 Selection, use and maintenance of respiratory protective equipment and AS/NZS 1716:2012 Respiratory protective devices.

<b>Sample Number:</b>	Not Sampled		
<b>Label Status</b>	Unlabelled	<b>If Mitigating Potential Risks, Consult:</b>	WorkSafe WA Code of Practice How to manage and control asbestos in the workplace 2022, Safe work practice 2 - Sealing, painting, coating and cleaning of asbestos cement products;  WorkSafe WA Code of Practice How to Safely Remove Asbestos 2022, Appendix 3, Respiratory protective equipment, AS/NZS 1715:2009 Selection, use and maintenance of respiratory protective equipment and AS/NZS 1716:2012 Respiratory protective devices.
<b>Laboratory Reference:</b>	-

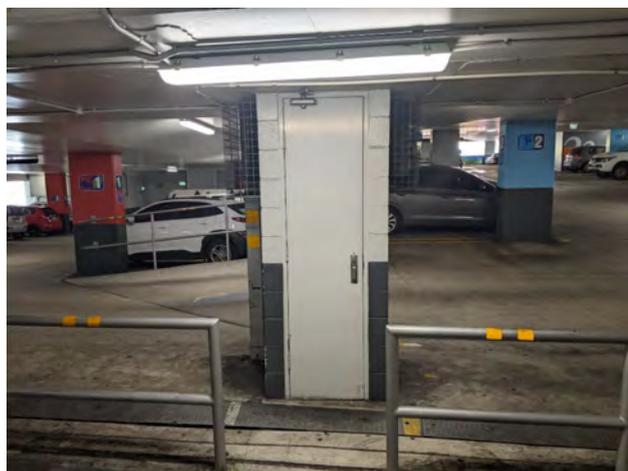
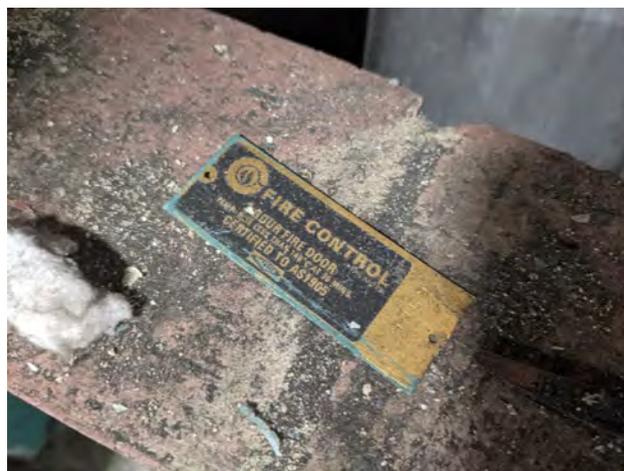
<b>Item Number:</b>	47718	<b>Action Rating:</b>	A2
<b>Location Description:</b>	Riser Cupboard Fire Door	<b>Risk Rating:</b>	Moderate
<b>Item:</b>	Fire door "unbadged"	<b>Friability</b>	Friable
<b>Material Description:</b>	Encapsulated Friable Material	<b>Disturbance Potential:</b>	Rare
<b>Extent (approx.):</b>	1 No.	<b>Condition:</b>	Poor (Damaged)
<b>Building:</b>	Car park	<b>Proposed Actions:</b>	These doors should be appropriately sealed or replaced by a licensed asbestos removal contractor.
<b>Level:</b>	All Floors (internal)	<b>Additional Comments:</b>	Level 3/4 is exposed and unsealed.
<b>Location Number:</b>	001		
<b>Sample Status:</b>	Assumed Asbestos	<b>If Removing, Consult:</b>	WorkSafe WA Code of Practice How to Safely Remove Asbestos 2022, Section 1.2 Licence requirements for Asbestos removal work;  WorkSafe WA Code of Practice How to Safely Remove Asbestos 2022, Appendix 3, Respiratory protective equipment, AS/NZS 1715:2009 Selection, use and maintenance of respiratory protective equipment and AS/NZS 1716:2012 Respiratory protective devices.

<b>Sample Number:</b>	Not Sampled		
<b>Label Status</b>	Labelled	<b>If Mitigating Potential Risks, Consult:</b>	WorkSafe WA Code of Practice How to manage and control asbestos in the workplace 2022, Section 2.6 Assessing the risk of exposure;  WorkSafe WA Code of Practice How to Safely Remove Asbestos 2022, Appendix 3, Respiratory protective equipment, AS/NZS 1715:2009 Selection, use and maintenance of respiratory protective equipment and AS/NZS 1716:2012 Respiratory protective devices.
<b>Laboratory Reference:</b>	-

- **The central service duct, accessible from all floors, has mostly unbadged fire doors in place, see item [47718](#). The door on level 3/4 was observed as having no cover plate or key mechanism with exposed and unsealed assumed asbestos material. These doors should be appropriately sealed or replaced by a licensed asbestos removal contractor.**

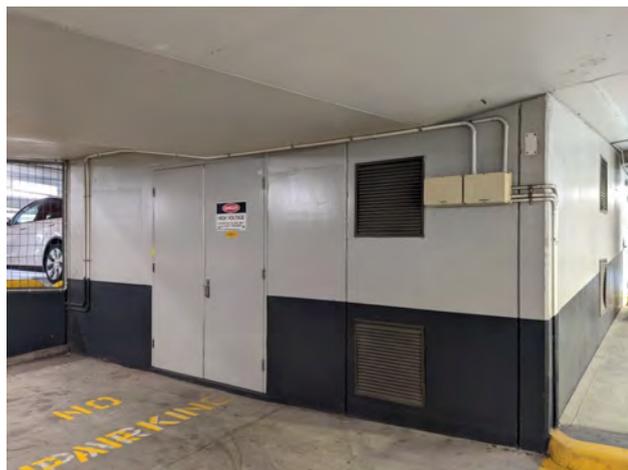
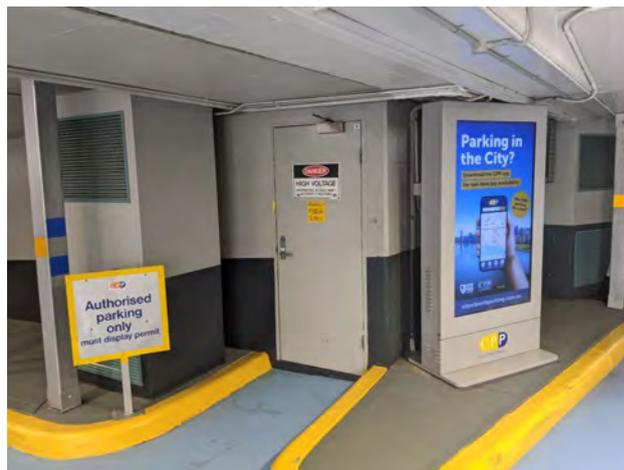
<b>Item Number:</b>	47719	<b>Action Rating:</b>	A3
<b>Location Description:</b>	Western Power HV Room	<b>Risk Rating:</b>	Unknown
<b>Item:</b>	Unknown	<b>Friability</b>	Unknown
<b>Material Description:</b>	Unknown	<b>Disturbance Potential:</b>	Unknown
<b>Extent (approx.):</b>	Unknown	<b>Condition:</b>	Unknown
<b>Building:</b>	Car park	<b>Proposed Actions:</b>	Inspect as soon as practicable
<b>Level:</b>	Ground Floor, Internal	<b>Additional Comments:</b>	<b>The room could not be accessed because the door was locked.</b>
<b>Location Number:</b>	001		
<b>Sample Status:</b>	Assumed Asbestos	<b>If Removing, Consult:</b>	<p>WorkSafe WA Code of Practice How to manage and control asbestos in the workplace 2022, Section 2.3 Assuming asbestos or ACM is present_Inaccessible areas;</p> <p>WorkSafe WA Code of Practice How to Safely Remove Asbestos 2022, Appendix 3, Respiratory protective equipment, AS/NZS 1715:2009 Selection, use and maintenance of respiratory protective equipment and AS/NZS 1716:2012 Respiratory protective devices.</p>

<b>Sample Number:</b>	Not Sampled		
<b>Label Status</b>	-	<b>If Mitigating Potential Risks, Consult:</b>	<p>WorkSafe WA Code of Practice How to manage and control asbestos in the workplace 2022, Section 2.3 Assuming asbestos or ACM is present_Inaccessible areas;</p> <p>WorkSafe WA Code of Practice How to Safely Remove Asbestos 2022, Appendix 3, Respiratory protective equipment, AS/NZS 1715:2009 Selection, use and maintenance of respiratory protective equipment and AS/NZS 1716:2012 Respiratory protective devices.</p>
<b>Laboratory Reference:</b>	-

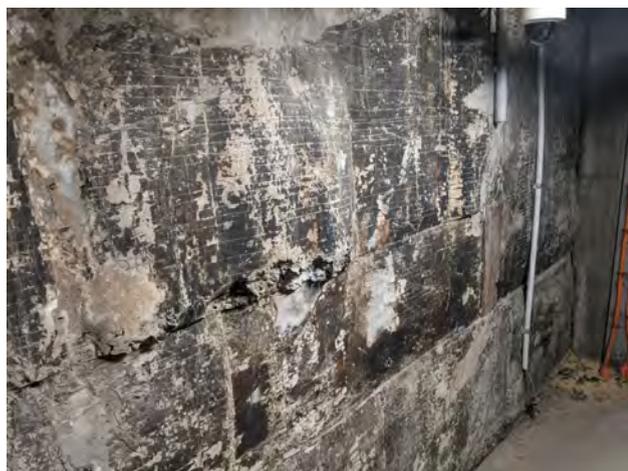
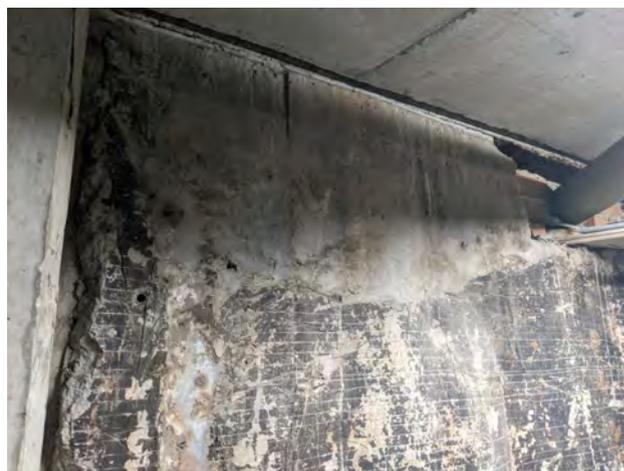
<b>Item Number:</b>	47720	<b>Action Rating:</b>	A4
<b>Location Description:</b>	Comms Room	<b>Risk Rating:</b>	Very Low
<b>Item:</b>	Waterproofing membrane	<b>Friability</b>	Non-Friable
<b>Material Description:</b>	Bituminous Product	<b>Disturbance Potential:</b>	Rare
<b>Extent (approx.):</b>	10 m <sup>2</sup>	<b>Condition:</b>	Fair (Minor Damage)
<b>Building:</b>	Car park	<b>Proposed Actions:</b>	Monitor and maintain existing sealant in good condition
<b>Level:</b>	Basement, Internal	<b>Additional Comments:</b>	Observed on the wall of the comms room, Isolate HVAC and sample prior to disturbance.
<b>Location Number:</b>	001		
<b>Sample Status:</b>	Assumed Asbestos	<b>If Removing, Consult:</b>	WorkSafe WA Code of Practice How to Safely Remove Asbestos 2022, Appendix 5, Removing bituminous (malthoid) products;  WorkSafe WA Code of Practice How to Safely Remove Asbestos 2022, Appendix 3, Respiratory protective equipment, AS/NZS 1715:2009 Selection, use and maintenance of respiratory protective equipment and AS/NZS 1716:2012 Respiratory protective devices.

<b>Sample Number:</b>	Not Sampled		
<b>Label Status</b>	Labelled	<b>If Mitigating Potential Risks, Consult:</b>	WorkSafe WA Code of Practice How to manage and control asbestos in the workplace 2022, Section 2.6 Assessing the risk of exposure;  WorkSafe WA Code of Practice How to Safely Remove Asbestos 2022, Appendix 3, Respiratory protective equipment, AS/NZS 1715:2009 Selection, use and maintenance of respiratory protective equipment and AS/NZS 1716:2012 Respiratory protective devices
<b>Laboratory Reference:</b>	-

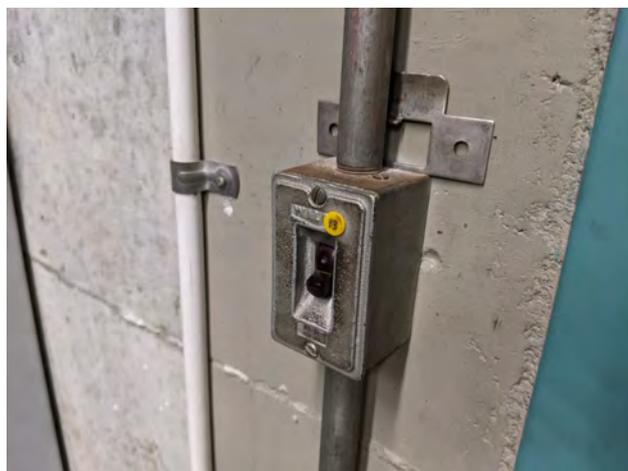
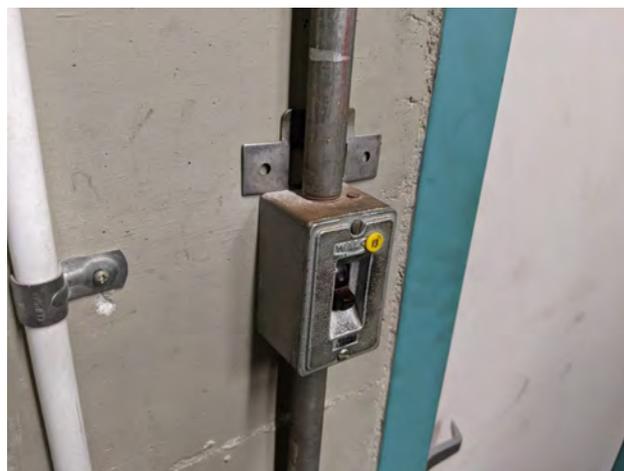
<b>Item Number:</b>	47721	<b>Action Rating:</b>	A4
<b>Location Description:</b>	Lift Motor Room (1,2 &)	<b>Risk Rating:</b>	Very Low
<b>Item:</b>	Wilco metallic switchgear	<b>Friability</b>	Non-Friable
<b>Material Description:</b>	Gaskets (compressed)	<b>Disturbance Potential:</b>	Rare
<b>Extent (approx.):</b>	1 No.	<b>Condition:</b>	Good (Undamaged)
<b>Building:</b>	Car park	<b>Proposed Actions:</b>	Removal by licensed asbestos contractor during refurbishment or demolition
<b>Level:</b>	Basement, Internal	<b>Additional Comments:</b>	Light switch to motor room for lifts 1,2 & 3
<b>Location Number:</b>	001		
<b>Sample Status:</b>	Assumed Asbestos	<b>If Removing, Consult:</b>	WorkSafe WA Code of Practice How to Safely Remove Asbestos 2022, Appendix 5, Page 92 - Removal of gaskets and rope seals;  WorkSafe WA Code of Practice How to Safely Remove Asbestos 2022, Appendix 3, Respiratory protective equipment, AS/NZS 1715:2009 Selection, use and maintenance of respiratory protective equipment and AS/NZS 1716:2012 Respiratory protective devices.

<b>Sample Number:</b>	Not Sampled		
<b>Label Status</b>	Unlabelled	<b>If Mitigating Potential Risks, Consult:</b>	WorkSafe WA Code of Practice How to manage and control asbestos in the workplace 2022, Section 2.6 Assessing the risk of exposure;  WorkSafe WA Code of Practice How to Safely Remove Asbestos 2022, Appendix 3 Respiratory protective equipment, AS/NZS 1715:2009 Selection, use and maintenance of respiratory protective equipment and AS/NZS 1716:2012 Respiratory protective devices.
<b>Laboratory Reference:</b>	-

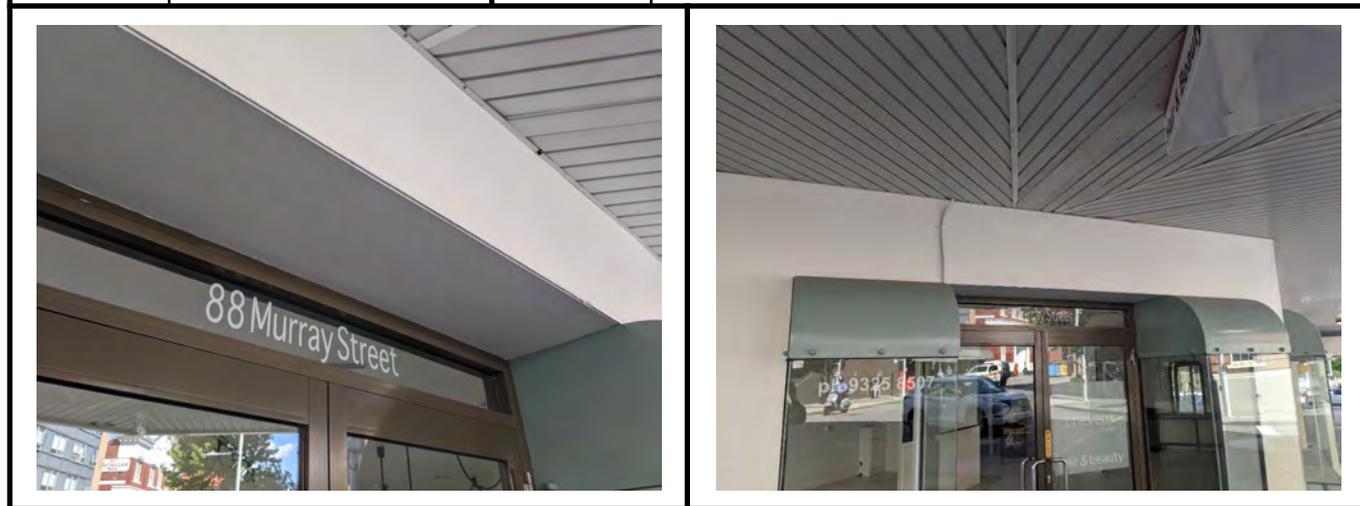
<b>Item Number:</b>	47722	<b>Action Rating:</b>	-
<b>Location Description:</b>	Murray St Entry	<b>Risk Rating:</b>	-
<b>Item:</b>	Upper infill panels	<b>Friability</b>	-
<b>Material Description:</b>	Cement Product	<b>Disturbance Potential:</b>	-
<b>Extent (approx.):</b>	m <sup>2</sup>	<b>Condition:</b>	-
<b>Building:</b>	Car park	<b>Proposed Actions:</b>	-
<b>Level:</b>	External Ground	<b>Additional Comments:</b>	Infill panel above auto doors.
<b>Location Number:</b>	001		
<b>Sample Status:</b>	No Asbestos Detected	<b>If Removing, Consult:</b>	-
<b>Sample Number:</b>	Previously sampled by QED as 09331		
<b>Label Status</b>	-	<b>If Mitigating Potential Risks, Consult:</b>	-
<b>Laboratory Reference:</b>	ARL Report No. 16-08298-02

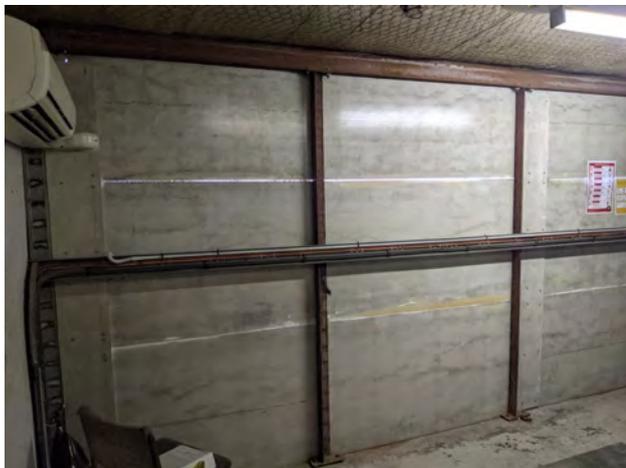
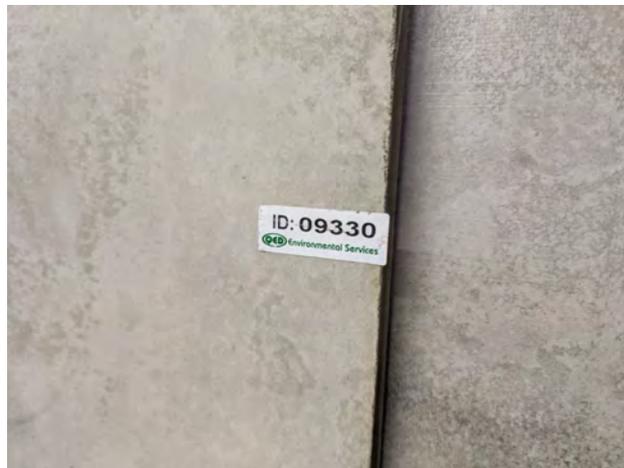
<b>Item Number:</b>	47723	<b>Action Rating:</b>	-
<b>Location Description:</b>	Lift Motor Room	<b>Risk Rating:</b>	-
<b>Item:</b>	Fibre cement wall panelling	<b>Friability</b>	-
<b>Material Description:</b>	Cement Product	<b>Disturbance Potential:</b>	-
<b>Extent (approx.):</b>	15 m <sup>2</sup>	<b>Condition:</b>	-
<b>Building:</b>	Car park	<b>Proposed Actions:</b>	-
<b>Level:</b>	Ground Floor, Internal	<b>Additional Comments:</b>	Labeled and dated Hardie Sheet.
<b>Location Number:</b>	001		
<b>Sample Status:</b>	No Asbestos Detected	<b>If Removing, Consult:</b>	-
<b>Sample Number:</b>	Previously sampled by QED as 09330		
<b>Label Status</b>	-	<b>If Mitigating Potential Risks, Consult:</b>	-
<b>Laboratory Reference:</b>	ARL Report No. 16-08298-01

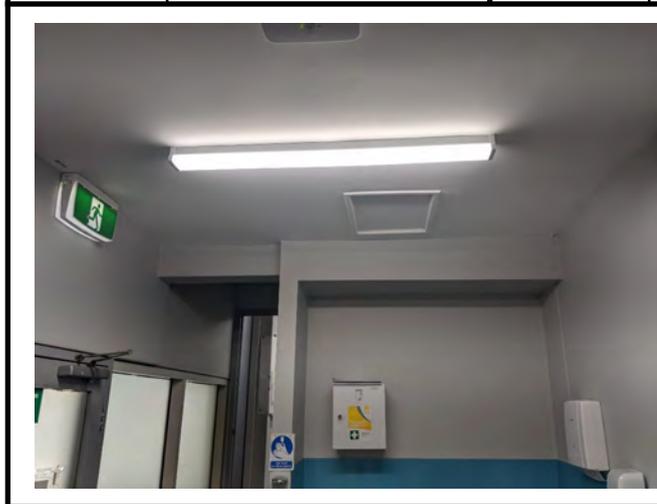
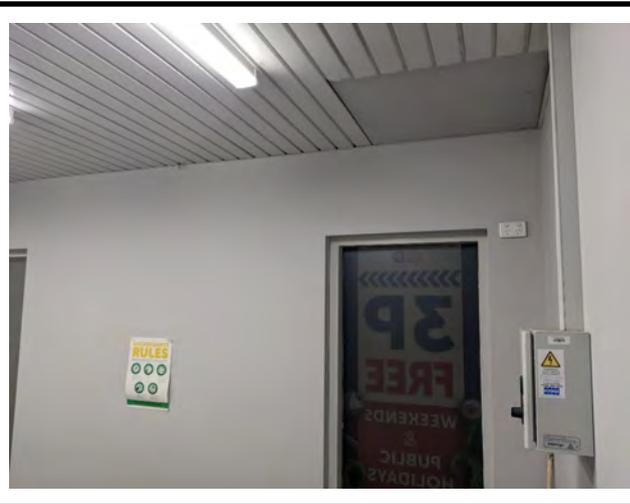
<b>Item Number:</b>	47724	<b>Action Rating:</b>	-
<b>Location Description:</b>	Pier St Lunch Room	<b>Risk Rating:</b>	-
<b>Item:</b>	Fascia infill panels	<b>Friability</b>	-
<b>Material Description:</b>	Cement Product	<b>Disturbance Potential:</b>	-
<b>Extent (approx.):</b>	Unknown	<b>Condition:</b>	-
<b>Building:</b>	Car park	<b>Proposed Actions:</b>	-
<b>Level:</b>	Ground Floor, Internal	<b>Additional Comments:</b>	Panels shown in QED Report No. 28418r0 could not be identified during the 2023 survey. COP representative confirmed that the locations in images below are the same location.
<b>Location Number:</b>	001		
<b>Sample Status:</b>	No Asbestos Detected	<b>If Removing, Consult:</b>	-
<b>Sample Number:</b>	Previously sampled by QED as 10430		
<b>Label Status</b>	-	<b>If Mitigating Potential Risks, Consult:</b>	-
<b>Laboratory Reference:</b>	AEC Report No. 96504

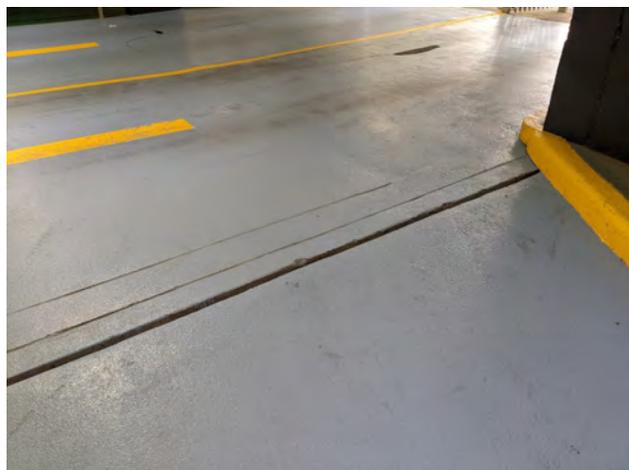
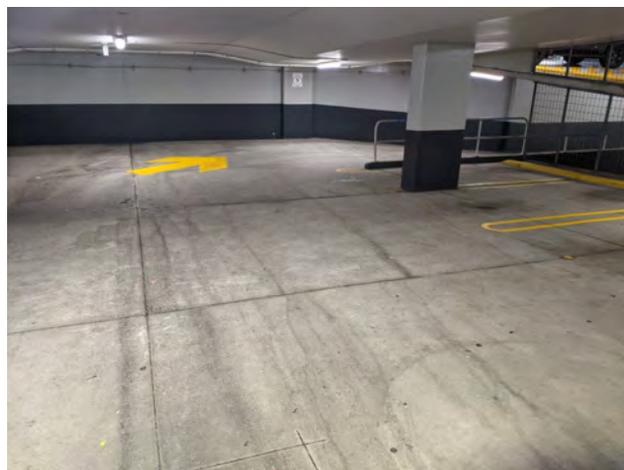
<b>Item Number:</b>	47725	<b>Action Rating:</b>	-
<b>Location Description:</b>	Expansion Joints	<b>Risk Rating:</b>	-
<b>Item:</b>	Expansion joint mastic	<b>Friability</b>	-
<b>Material Description:</b>	Mastic	<b>Disturbance Potential:</b>	-
<b>Extent (approx.):</b>	Throughout lin m	<b>Condition:</b>	-
<b>Building:</b>	Car park	<b>Proposed Actions:</b>	-
<b>Level:</b>	All Floors (internal)	<b>Additional Comments:</b>	-
<b>Location Number:</b>	001		
<b>Sample Status:</b>	No Asbestos Detected	<b>If Removing, Consult:</b>	-
<b>Sample Number:</b>	Previously sampled by QED as 10065		
<b>Label Status</b>	-	<b>If Mitigating Potential Risks, Consult:</b>	-
<b>Laboratory Reference:</b>	AEC Report No. 93121

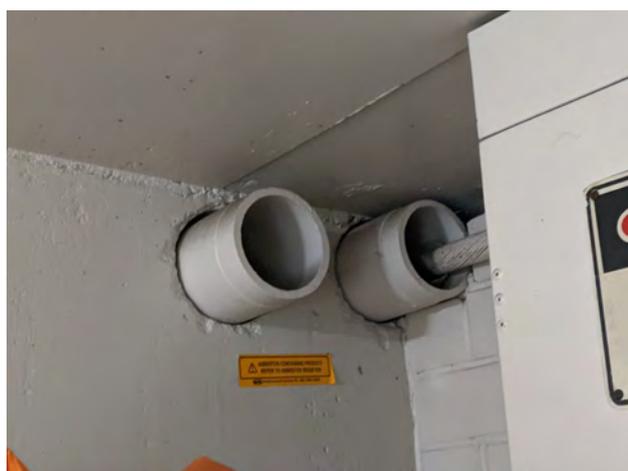
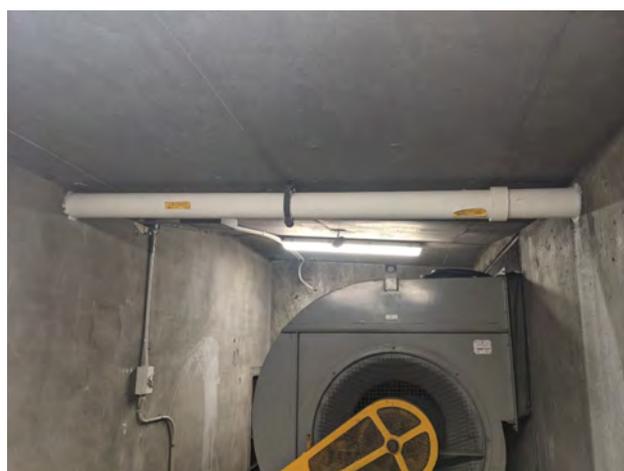
<b>Item Number:</b>	47726	<b>Action Rating:</b>	A4
<b>Location Description:</b>	Wall Penetrations	<b>Risk Rating:</b>	Very Low
<b>Item:</b>	Service conduits	<b>Friability</b>	Non-Friable
<b>Material Description:</b>	Cement Product	<b>Disturbance Potential:</b>	Rare
<b>Extent (approx.):</b>	Unknown No.	<b>Condition:</b>	Good (Undamaged)
<b>Building:</b>	Car park	<b>Proposed Actions:</b>	Monitor and maintain in good condition
<b>Level:</b>	Basement, Internal	<b>Additional Comments:</b>	Observed in basement EF-1, assumed to be present throughout the car park.
<b>Location Number:</b>	001		
<b>Sample Status:</b>	Assumed Asbestos	<b>If Removing, Consult:</b>	WorkSafe WA Code of Practice How to Safely Remove Asbestos 2022, Appendix 5, Asbestos cement products.  WorkSafe WA Code of Practice How to Safely Remove Asbestos 2022, Appendix 3, Respiratory protective equipment, AS/NZS 1715:2009 Selection, use and maintenance of respiratory protective equipment and AS/NZS 1716:2012 Respiratory protective devices.

<b>Sample Number:</b>	Not Sampled		
<b>Label Status</b>	Labelled	<b>If Mitigating Potential Risks, Consult:</b>	WorkSafe WA Code of Practice How to manage and control asbestos in the workplace 2022, Safe work practice 2 - Sealing, painting, coating and cleaning of asbestos cement products;  WorkSafe WA Code of Practice How to manage and control asbestos in the workplace 2022, Appendix 7, Safe work practice 4 — Replacing cabling in asbestos cement conduits or boxes.  WorkSafe WA Code of Practice How to Safely Remove Asbestos 2022, Appendix 3, Respiratory protective equipment, AS/NZS 1715:2009 Selection, use and maintenance of respiratory protective equipment and AS/NZS 1716:2012 Respiratory protective devices.
<b>Laboratory Reference:</b>	-

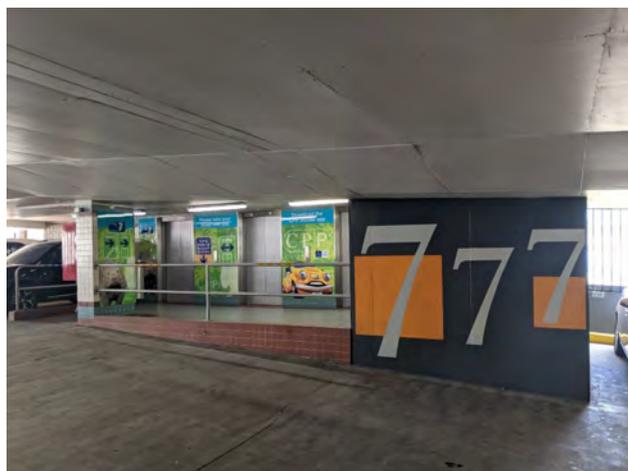
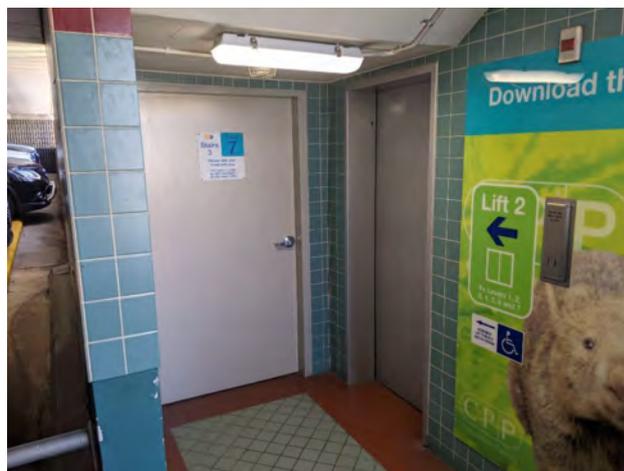
<b>Item Number:</b>	47727	<b>Action Rating:</b>	A4
<b>Location Description:</b>	Elevator Lobbies	<b>Risk Rating:</b>	Very Low
<b>Item:</b>	Elevator fire doors	<b>Friability</b>	Encapsulated Friable Material
<b>Material Description:</b>	Encapsulated Friable Material	<b>Disturbance Potential:</b>	Rare
<b>Extent (approx.):</b>	Est 28 No	<b>Condition:</b>	Good (Undamaged)
<b>Building:</b>	Car park	<b>Proposed Actions:</b>	Monitor and maintain in good condition
<b>Level:</b>	All Floors (internal)	<b>Additional Comments:</b>	Bank of 3 lifts and bank of 1 lift.
<b>Location Number:</b>	001		
<b>Sample Status:</b>	Assumed Asbestos	<b>If Removing, Consult:</b>	WorkSafe WA Code of Practice How to Safely Remove Asbestos 2022, Section 3.12 Removing friable asbestos;  WorkSafe WA Code of Practice How to Safely Remove Asbestos 2022, Appendix 3, Respiratory protective equipment, AS/NZS 1715:2009 Selection, use and maintenance of respiratory protective equipment and AS/NZS 1716:2012 Respiratory protective devices.

<b>Sample Number:</b>	Not Sampled		
<b>Label Status</b>	Unlabelled	<b>If Mitigating Potential Risks, Consult:</b>	WorkSafe WA Code of Practice How to manage and control asbestos in the workplace 2022, Section 2.6 Assessing the risk of exposure;  WorkSafe WA Code of Practice How to Safely Remove Asbestos 2022, Appendix 3, Respiratory protective equipment, AS/NZS 1715:2009 Selection, use and maintenance of respiratory protective equipment and AS/NZS 1716:2012 Respiratory protective devices.
<b>Laboratory Reference:</b>	-

- **Elevator doors in their current state are considered encapsulated, if refurbishment or replacement works are planned, there is a high likelihood that disturbing the elevator doors will change their [condition assessment](#). ENVSS suggests invasive sampling of the elevator doors and further consultation on their in situ management or their safe and effective removal.**

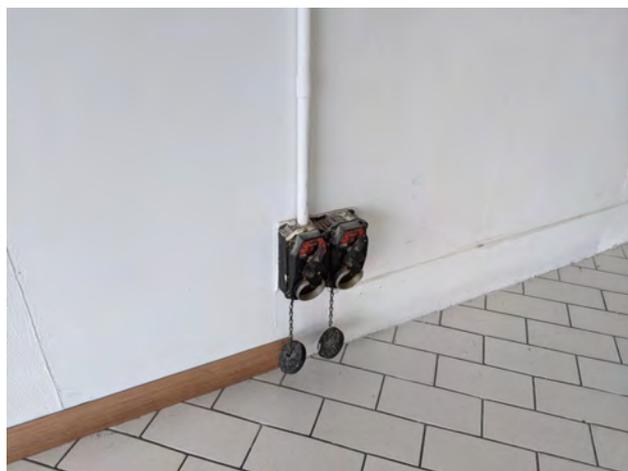
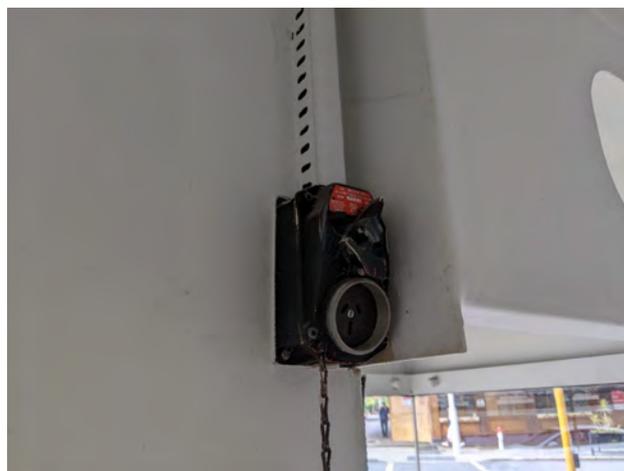
<b>Item Number:</b>	47730	<b>Action Rating:</b>	A4
<b>Location Description:</b>	Cheveux Hair	<b>Risk Rating:</b>	Very Low
<b>Item:</b>	Wilco metallic switchgear	<b>Friability</b>	Non-Friable
<b>Material Description:</b>	Gaskets (compressed)	<b>Disturbance Potential:</b>	Rare
<b>Extent (approx.):</b>	3 No.	<b>Condition:</b>	Good (Undamaged)
<b>Building:</b>	Tenancy - Cheveux Hair (formerly)	<b>Proposed Actions:</b>	Removal by licensed asbestos contractor during maintenance, refurbishment or demolition
<b>Level:</b>	Ground Floor, Internal	<b>Additional Comments:</b>	On western elevation and adjacent to the entry door, surface mounted.
<b>Location Number:</b>	004		
<b>Sample Status:</b>	Assumed Asbestos	<b>If Removing, Consult:</b>	WorkSafe WA Code of Practice How to Safely Remove Asbestos 2022, Appendix 5, Page 92 - Removal of gaskets and rope seals;  WorkSafe WA Code of Practice How to Safely Remove Asbestos 2022, Appendix 3, Respiratory protective equipment, AS/NZS 1715:2009 Selection, use and maintenance of respiratory protective equipment and AS/NZS 1716:2012 Respiratory protective devices.

<b>Sample Number:</b>	Not Sampled		
<b>Label Status</b>	Unlabelled	<b>If Mitigating Potential Risks, Consult:</b>	WorkSafe WA Code of Practice How to manage and control asbestos in the workplace 2022, Section 2.6 Assessing the risk of exposure;  WorkSafe WA Code of Practice How to Safely Remove Asbestos 2022, Appendix 3 Respiratory protective equipment, AS/NZS 1715:2009 Selection, use and maintenance of respiratory protective equipment and AS/NZS 1716:2012 Respiratory protective devices.
<b>Laboratory Reference:</b>	-

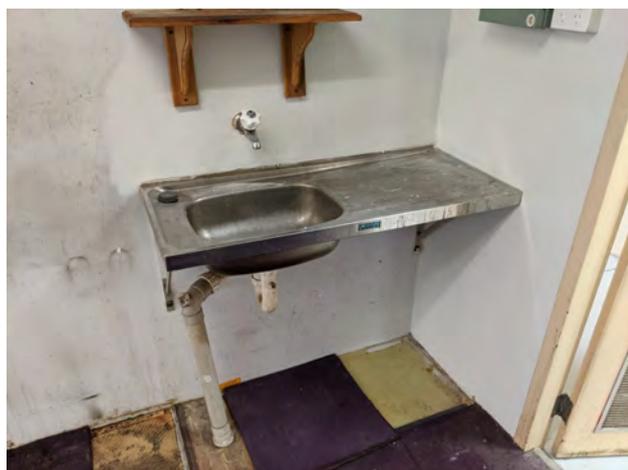
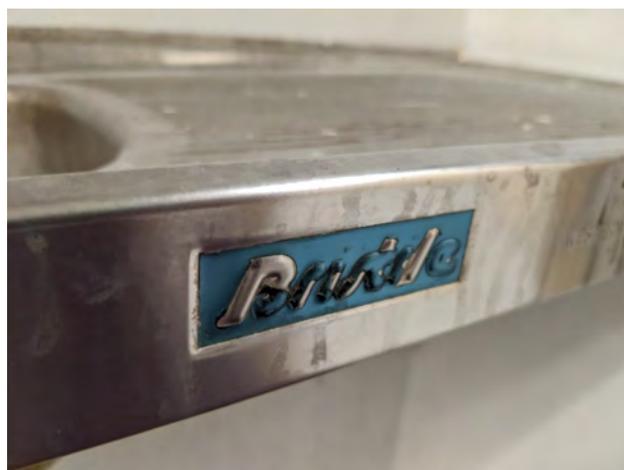
<b>Item Number:</b>	47728	<b>Action Rating:</b>	A4
<b>Location Description:</b>	Pawn Broker - Sink	<b>Risk Rating:</b>	Very Low
<b>Item:</b>	Sink sound dampening membrane	<b>Friability</b>	Non-Friable
<b>Material Description:</b>	Bituminous Product	<b>Disturbance Potential:</b>	Rare
<b>Extent (approx.):</b>	1 No.	<b>Condition:</b>	Good (Undamaged)
<b>Building:</b>	Tenancy - Pawn Broker	<b>Proposed Actions:</b>	Removal by licensed asbestos contractor during refurbishment or demolition
<b>Level:</b>	Ground Floor, Internal	<b>Additional Comments:</b>	Bristle branded sink
<b>Location Number:</b>	002		
<b>Sample Status:</b>	Assumed Asbestos	<b>If Removing, Consult:</b>	<p>WorkSafe WA Code of Practice How to Safely Remove Asbestos 2022, Appendix 5, Removing bituminous (malthoid) products;</p> <p>WorkSafe WA Code of Practice How to Safely Remove Asbestos 2022, Appendix 3, Respiratory protective equipment, AS/NZS 1715:2009 Selection, use and maintenance of respiratory protective equipment and AS/NZS 1716:2012 Respiratory protective devices</p>

<b>Sample Number:</b>	Not Sampled		
<b>Label Status</b>	Labelled	<b>If Mitigating Potential Risks, Consult:</b>	<p>WorkSafe WA Code of Practice How to manage and control asbestos in the workplace 2022, Section 2.6 Assessing the risk of exposure;</p> <p>WorkSafe WA Code of Practice How to Safely Remove Asbestos 2022, Appendix 3, Respiratory protective equipment, AS/NZS 1715:2009 Selection, use and maintenance of respiratory protective equipment and AS/NZS 1716:2012 Respiratory protective devices.</p>
<b>Laboratory Reference:</b>	-

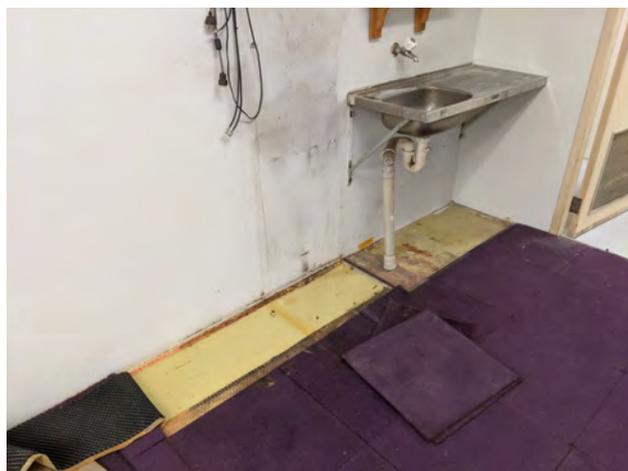
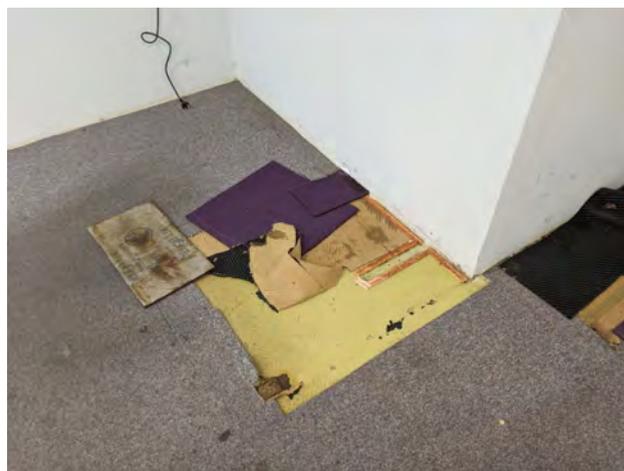
<b>Item Number:</b>	47729	<b>Action Rating:</b>	A4
<b>Location Description:</b>	Tenancy - Pawn Broker	<b>Risk Rating:</b>	Very Low
<b>Item:</b>	Vinyl flooring	<b>Friability</b>	Non-Friable
<b>Material Description:</b>	Vinyl Tiles	<b>Disturbance Potential:</b>	Low
<b>Extent (approx.):</b>	65 m <sup>2</sup>	<b>Condition:</b>	Good (Undamaged)
<b>Building:</b>	Tenancy - Pawn Broker	<b>Proposed Actions:</b>	Removal by licensed asbestos contractor during refurbishment or demolition
<b>Level:</b>	Ground Floor, Internal	<b>Additional Comments:</b>	The vinyl sheet appears to run under the full floor area.
<b>Location Number:</b>	002		
<b>Sample Status:</b>	Assumed Asbestos	<b>If Removing, Consult:</b>	WorkSafe WA Code of Practice How to Safely Remove Asbestos 2022, Appendix 5, Removal of floor tiles;  WorkSafe WA Code of Practice How to Safely Remove Asbestos 2022, Appendix 3, Respiratory protective equipment, AS/NZS 1715:2009 Selection, use and maintenance of respiratory protective equipment and AS/NZS 1716:2012 Respiratory protective devices.

<b>Sample Number:</b>	Not Sampled		
<b>Label Status</b>	Labelled	<b>If Mitigating Potential Risks, Consult:</b>	WorkSafe WA Code of Practice How to manage and control asbestos in the workplace 2022, Section 2.6 Assessing the risk of exposure;  WorkSafe WA Code of Practice How to Safely Remove Asbestos 2022, Appendix 3, Respiratory protective equipment, AS/NZS 1715:2009 Selection, use and maintenance of respiratory protective equipment and AS/NZS 1716:2012 Respiratory protective devices
<b>Laboratory Reference:</b>	-
