Architectural Services for Design of the  
Commercial Enhancement of Pier Street Car Park.

# ASBESTOS REGISTER

## Pier Street Car Park and Retail

87-89 Pier Street, Perth 6000

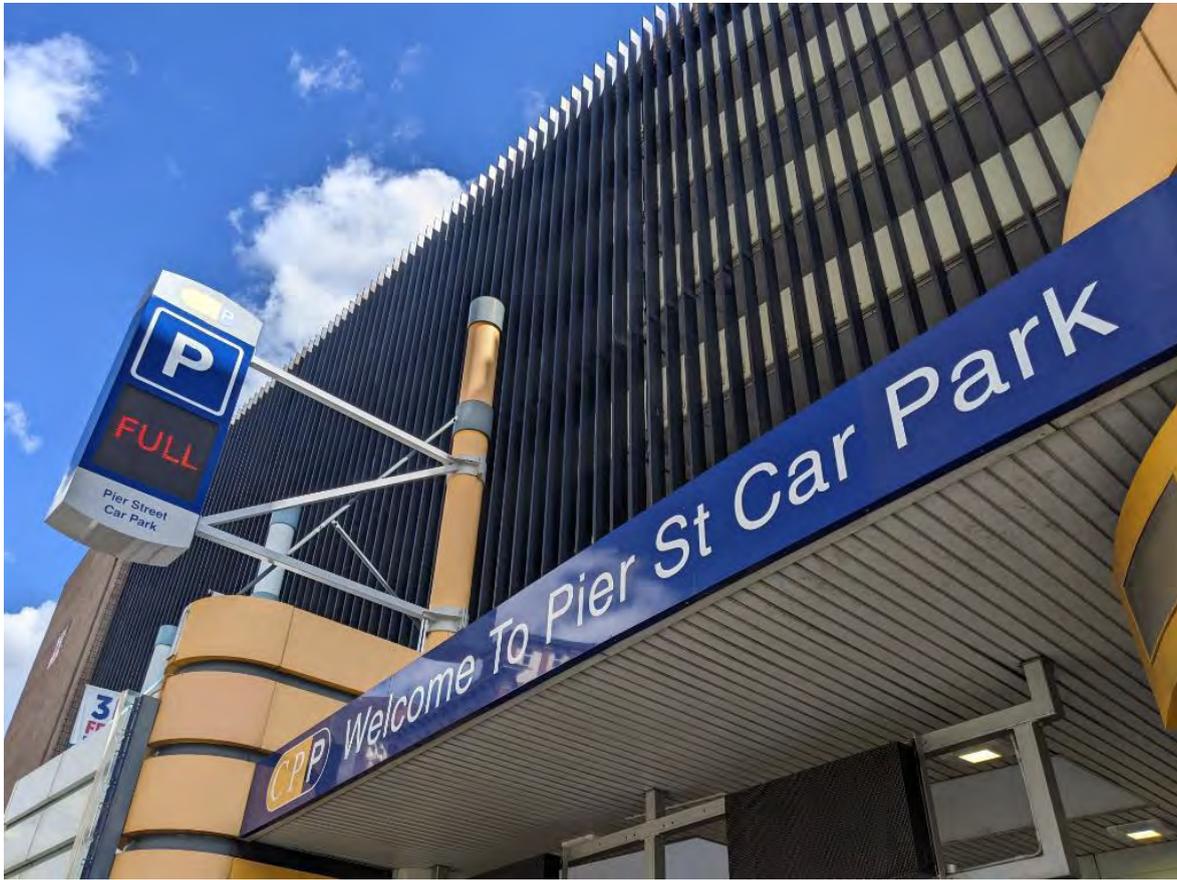
<b>Item Number:</b>	47714	<b>Action Rating:</b>	A4
<b>Location Description:</b>	EF2 & AHU 2	<b>Risk Rating:</b>	Very Low
<b>Item:</b>	Fibre cement wall sheet	<b>Friability</b>	Non-Friable
<b>Material Description:</b>	Cement Product	<b>Disturbance Potential:</b>	Rare
<b>Extent (approx.):</b>	1 m <sup>2</sup>	<b>Condition:</b>	Good (Undamaged)
<b>Building:</b>	Car park	<b>Proposed Actions:</b>	Removal by licensed asbestos contractor during refurbishment or demolition
<b>Level:</b>	Ground Floor, Internal	<b>Additional Comments:</b>	Unsealed, recommend sealing and reapplying warning labels.
<b>Location Number:</b>	001		
<b>Sample Status:</b>	Asbestos Detected	<b>If Removing, Consult:</b>	WorkSafe WA Code of Practice How to Safely Remove Asbestos 2022, Appendix 5, Asbestos cement products;  WorkSafe WA Code of Practice How to Safely Remove Asbestos 2022, Appendix 3, Respiratory protective equipment, AS/NZS 1715:2009 Selection, use and maintenance of respiratory protective equipment and AS/NZS 1716:2012 Respiratory protective devices.

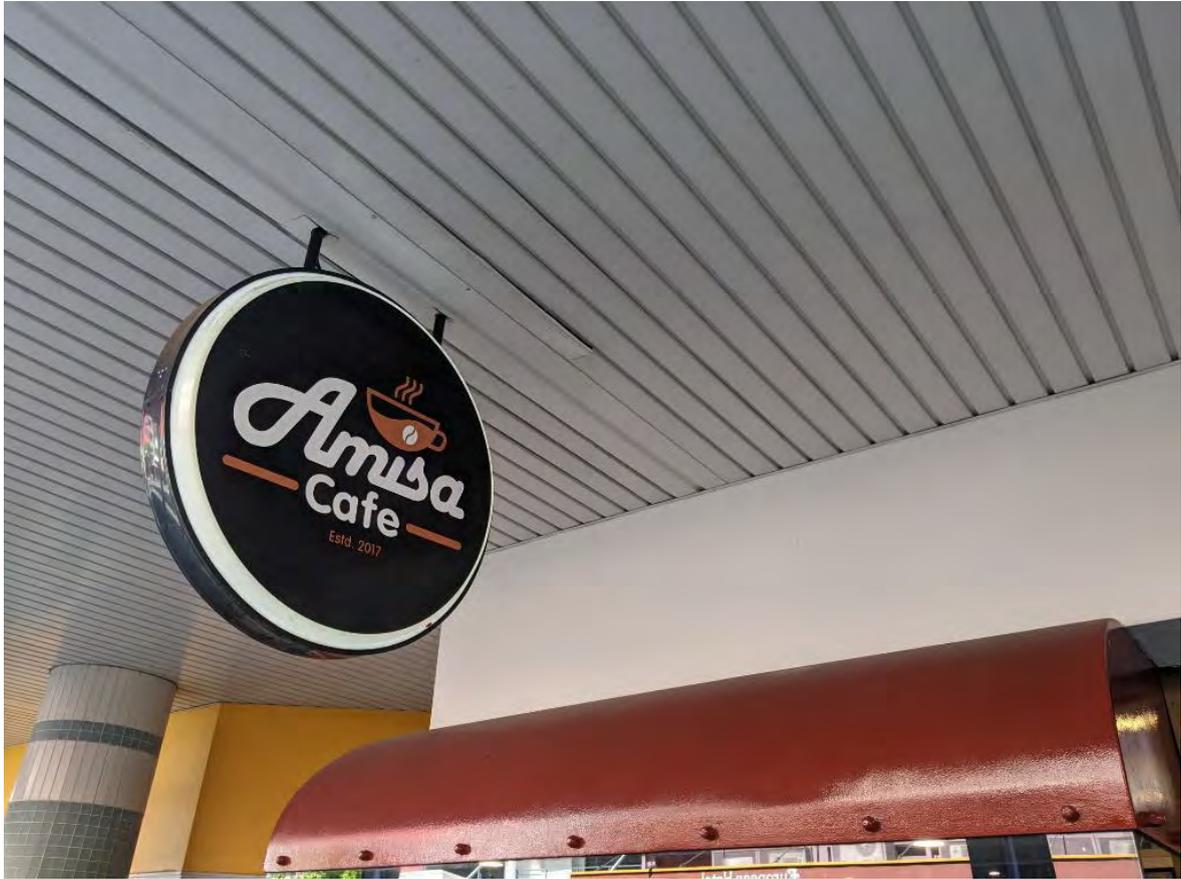
Tenancy - Amisa Cafe

No Suspect Materials Identified

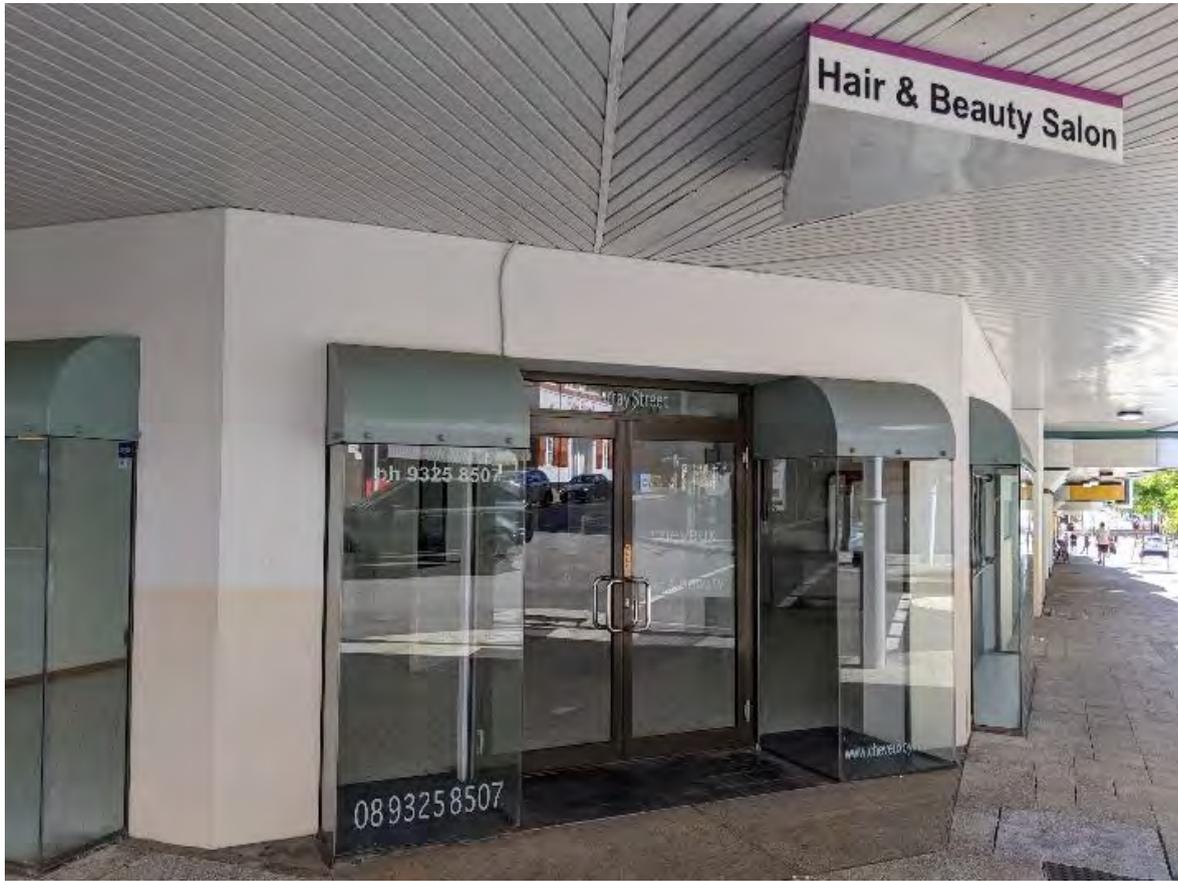
Tenancy - Cheveux Hair (Formerly)

<b>Item Number:</b>	47730	<b>Action Rating:</b>	A4
<b>Location Description:</b>	Cheveux Hair	<b>Risk Rating:</b>	Very Low
<b>Item:</b>	Wilco metallic switchgear	<b>Friability</b>	Non-Friable
<b>Material Description:</b>	Gaskets (compressed)	<b>Disturbance Potential:</b>	Rare
<b>Extent (approx.):</b>	3 No.	<b>Condition:</b>	Good (Undamaged)
<b>Building:</b>	Tenancy - Cheveux Hair (formerly)	<b>Proposed Actions:</b>	Removal by licensed asbestos contractor during maintenance, refurbishment or demolition
<b>Level:</b>	Ground Floor, Internal	<b>Additional Comments:</b>	On western elevation and adjacent to the entry door, surface mounted.
<b>Location Number:</b>	004		
<b>Sample Status:</b>	Assumed Asbestos	<b>If Removing, Consult:</b>	WorkSafe WA Code of Practice How to Safely Remove Asbestos 2022, Appendix 5, Page 92 - Removal of gaskets and rope seals;  WorkSafe WA Code of Practice How to Safely Remove Asbestos 2022, Appendix 3, Respiratory protective equipment, AS/NZS 1715:2009 Selection, use and maintenance of respiratory protective equipment and AS/NZS 1716:2012 Respiratory protective devices.

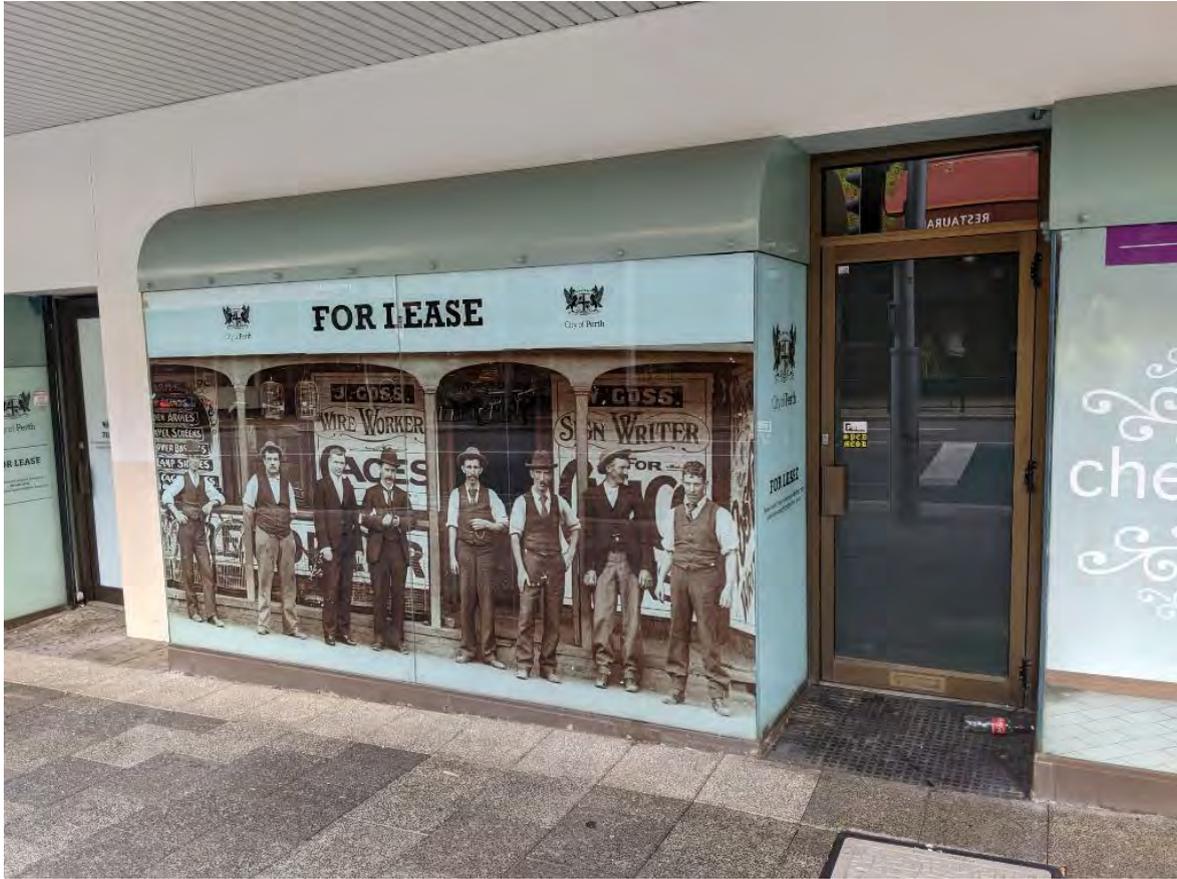
Tenancy - Optometrist (Formerly)

No Suspect Materials Identified

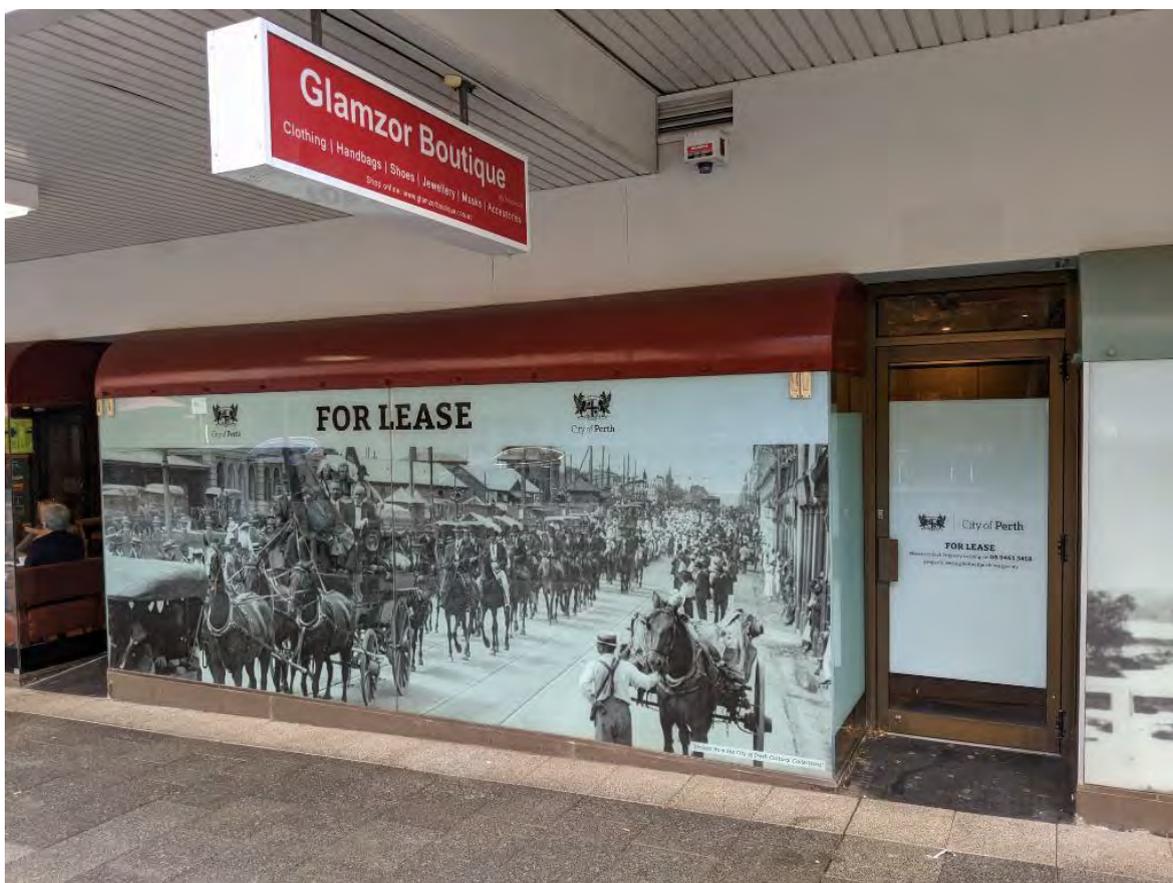
Tenancy - Pawn Broker (Formerly)

<b>Item Number:</b>	47728	<b>Action Rating:</b>	A4
<b>Location Description:</b>	Pawn Broker - Sink	<b>Risk Rating:</b>	Very Low
<b>Item:</b>	Sink sound dampening membrane	<b>Friability</b>	Non-Friable
<b>Material Description:</b>	Bituminous Product	<b>Disturbance Potential:</b>	Rare
<b>Extent (approx.):</b>	1 No.	<b>Condition:</b>	Good (Undamaged)
<b>Building:</b>	Tenancy - Pawn Broker	<b>Proposed Actions:</b>	Removal by licensed asbestos contractor during refurbishment or demolition
<b>Level:</b>	Ground Floor, Internal	<b>Additional Comments:</b>	Bristle branded sink
<b>Location Number:</b>	002		
<b>Sample Status:</b>	Assumed Asbestos	<b>If Removing, Consult:</b>	<p>WorkSafe WA Code of Practice How to Safely Remove Asbestos 2022, Appendix 5, Removing bituminous (malthoid) products;</p> <p>WorkSafe WA Code of Practice How to Safely Remove Asbestos 2022, Appendix 3, Respiratory protective equipment, AS/NZS 1715:2009 Selection, use and maintenance of respiratory protective equipment and AS/NZS 1716:2012 Respiratory protective devices</p>
